Report of Stormwater Infiltration Evaluation

October 25, 2022

Proposed Stormwater Management System

501 Washington Lane

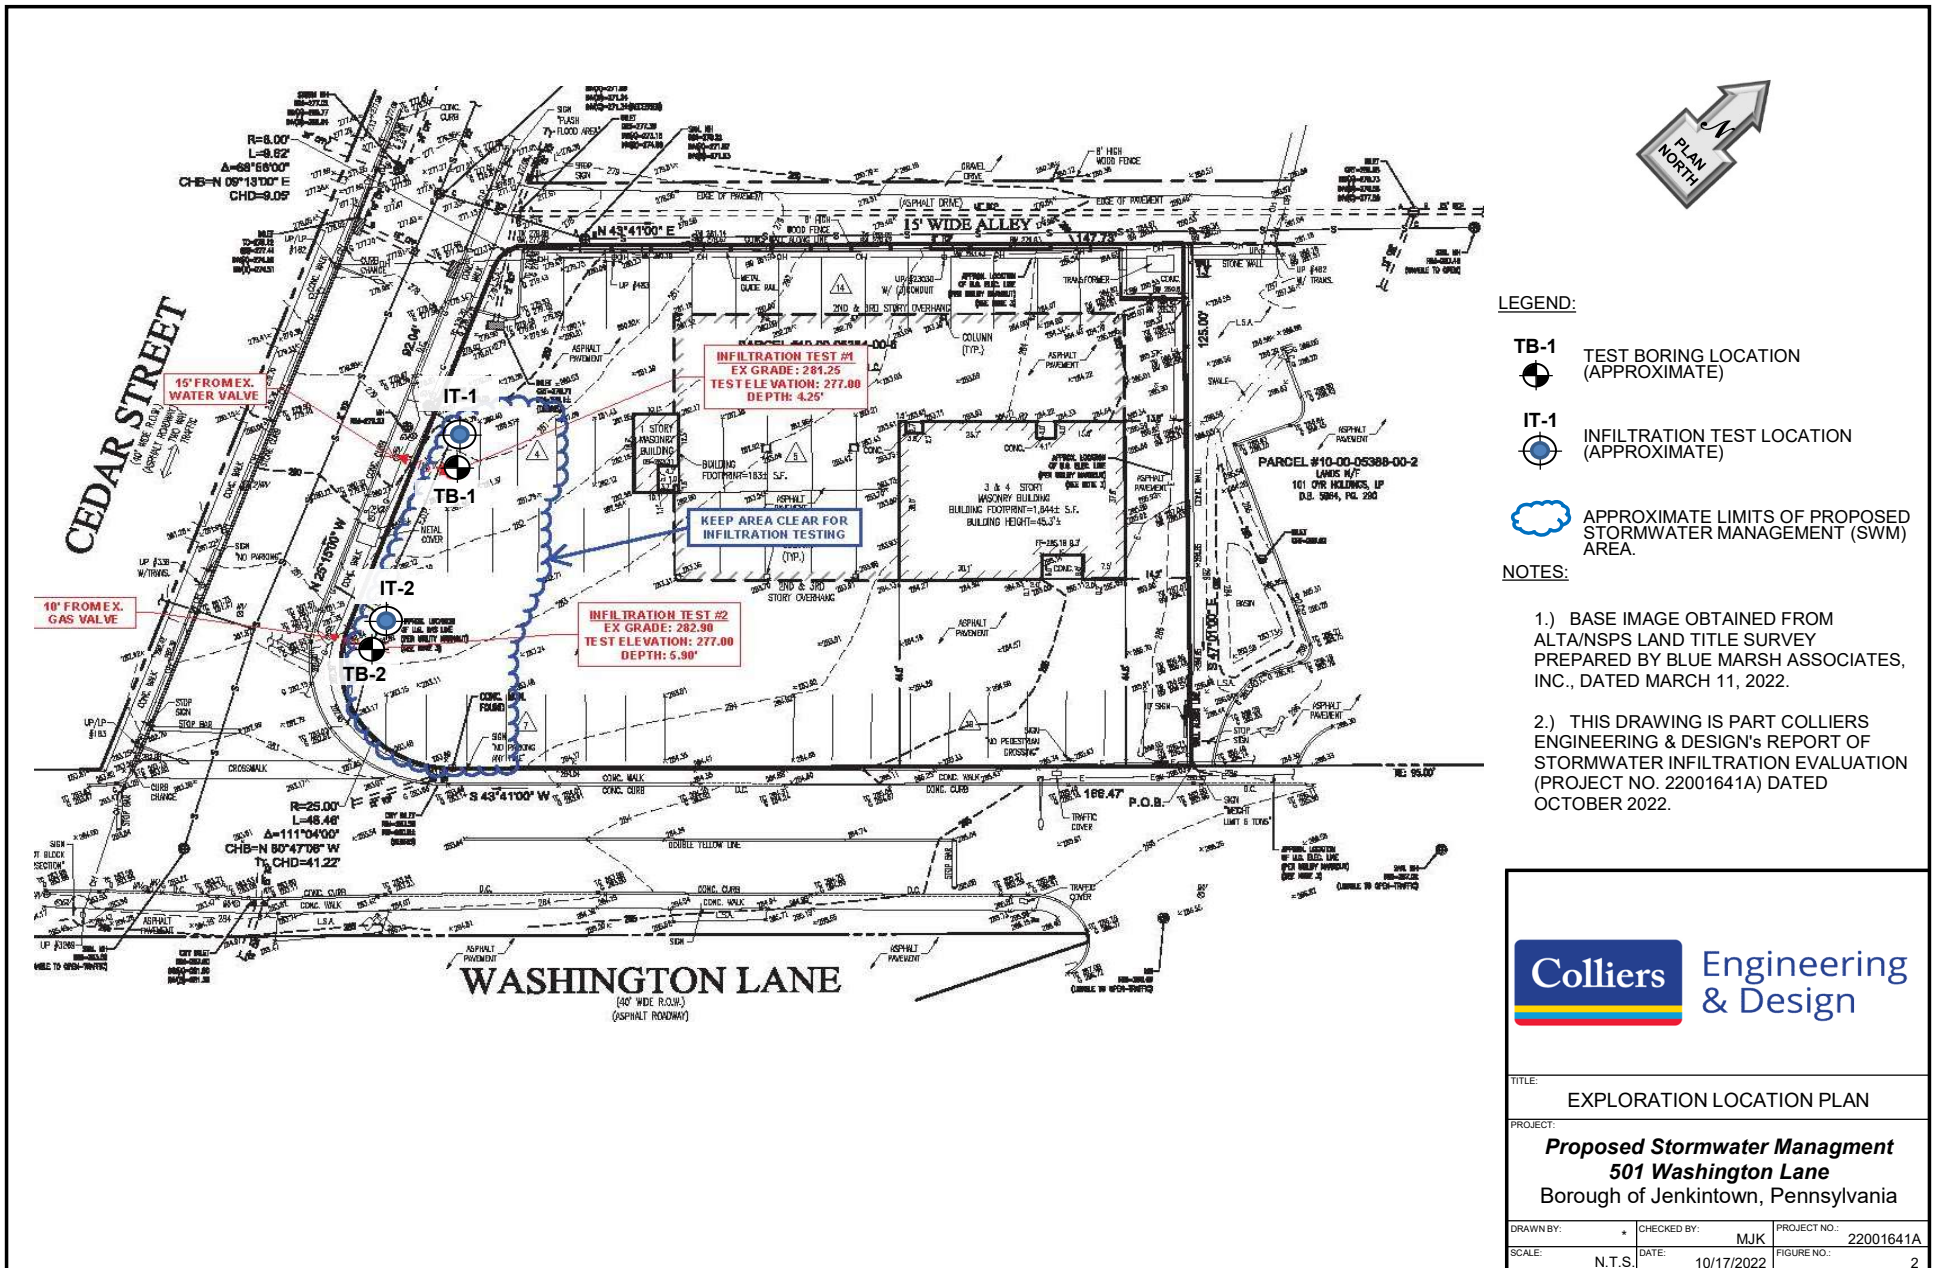
Two infiltration tests (IT-1 and IT-2) were performed at the locations shown on the attached Figure 2 – Exploration Location Plan. The tests were performed using the cased borehole infiltration test method seated in the soils at or near the anticipated basin bottom elevation. The results of the infiltration testing are summarized below in Table 2. Please also refer to the attached Stormwater Infiltration Testing Logs.

The soils at the infiltration test depths (bottom of basin) were relatively consistent. However, the rates were somewhat variable. The slower infiltration rate observed at IT-1 (southwest end of the basin) is likely the result of a poorly graded sand with moderate to high percentages of fine-grained soils observed at the test depth. Conversely, the faster infiltration rate observed at IT-2 (southeast end of the basin) was likely a product of poorly graded sand with moderately low percentages of fine-grained soils observed at the test depth.

We recommend that the basin be designed based on the more conservative rate measured at IT-1, after applying an appropriate factor of safety. The soils at the proposed basin bottom will likely consist of loose silty or clayey granular Stratum A soils. The faster draining loose zones of poorly graded sand with silt are expected to be relatively thin and at greater depths, where present. As a result, infiltration within the basin will likely be more represented by the silty or clayey sands identified at test location IT-1.
